FROM: California Fatality Assessment and Control Evaluation (CA/FACE) Program

SUBJECT: A Facility Maintenance Mechanic Died When Crushed Between an Overhead Bridge Crane and Light Fixture

SUMMARY
California FACE Report #05CA011

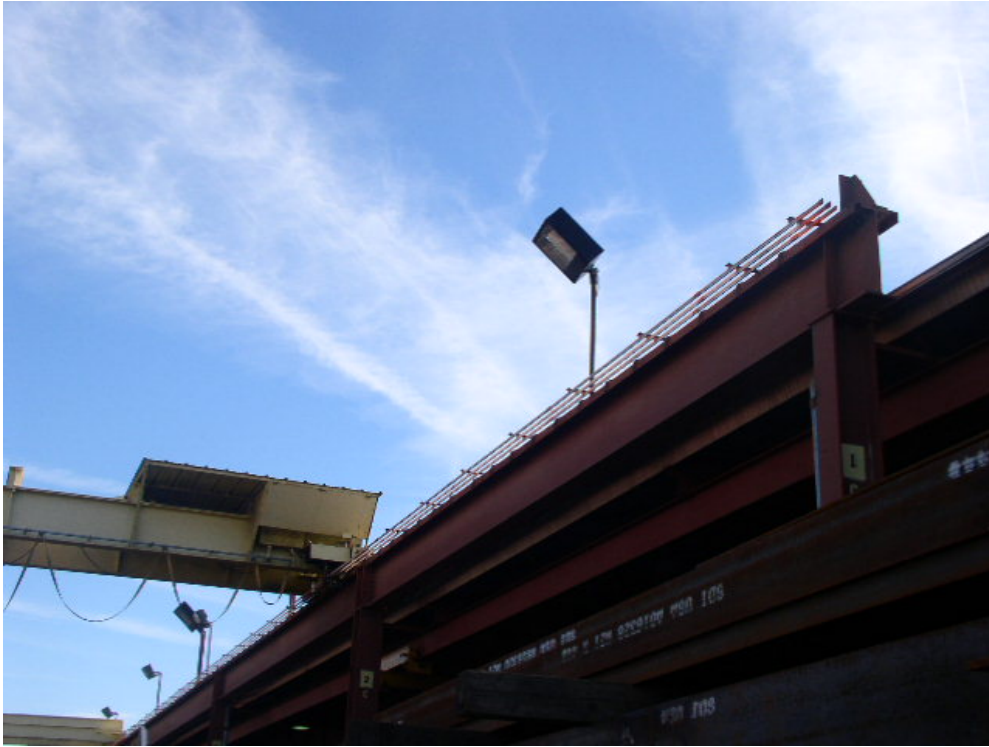
Exhibit 1. The gantry crane that was involved in the incident.

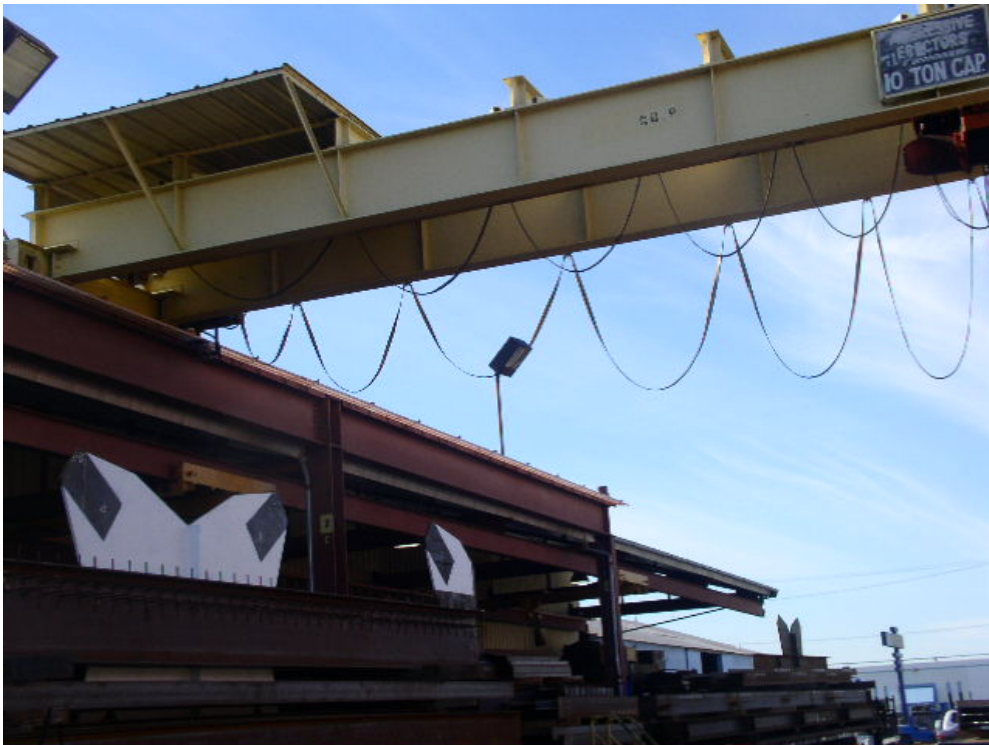
Exhibit 2. The gantry crane from a different angle.

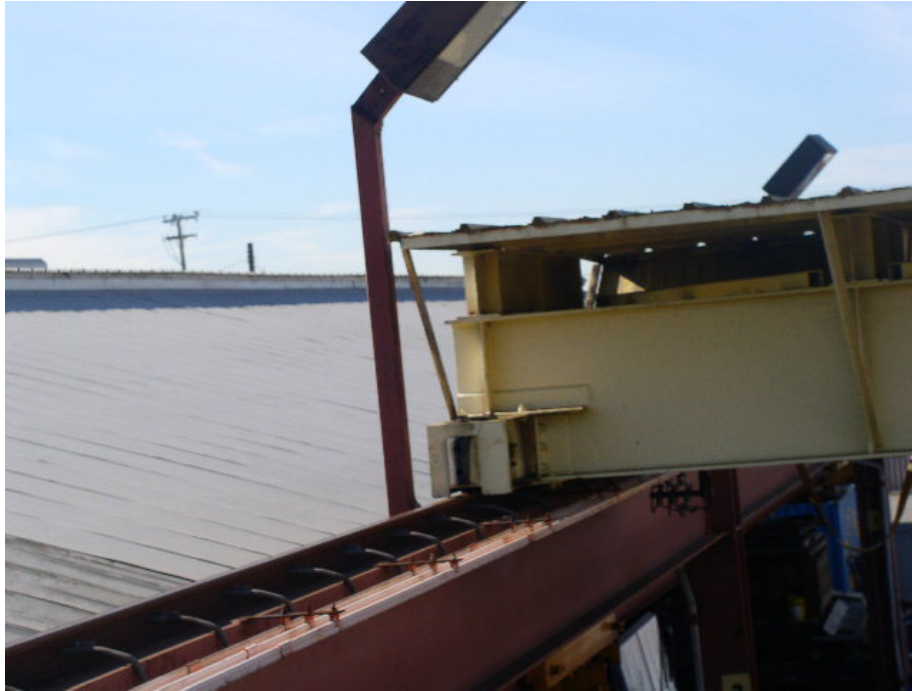
Exhibit 3. The gantry crane and the light standard against which the victim was crushed.

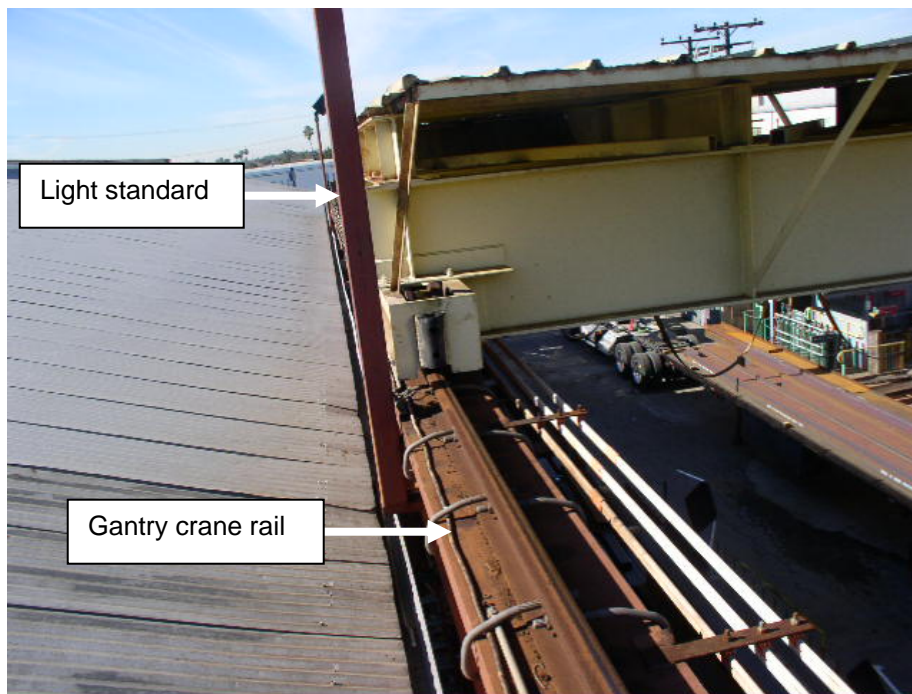
Exhibit 4. The rail the gantry crane rides on and the close proximity to the light standard.
